Multimodality imaging of pancreatic trauma

G Sugrue, Y Zhang, J Walsh, B Niu, N Murray, S Nicolaou

Vancouver General Hospital, Vancouver, Canada.

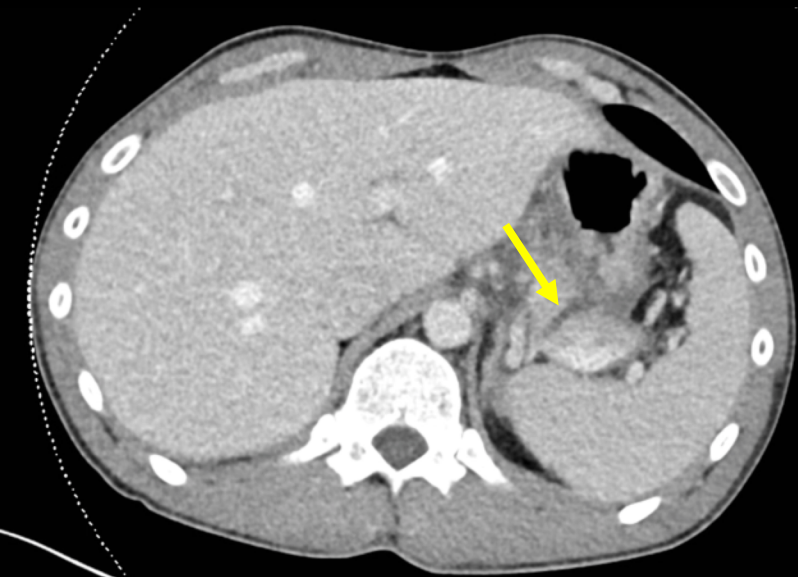
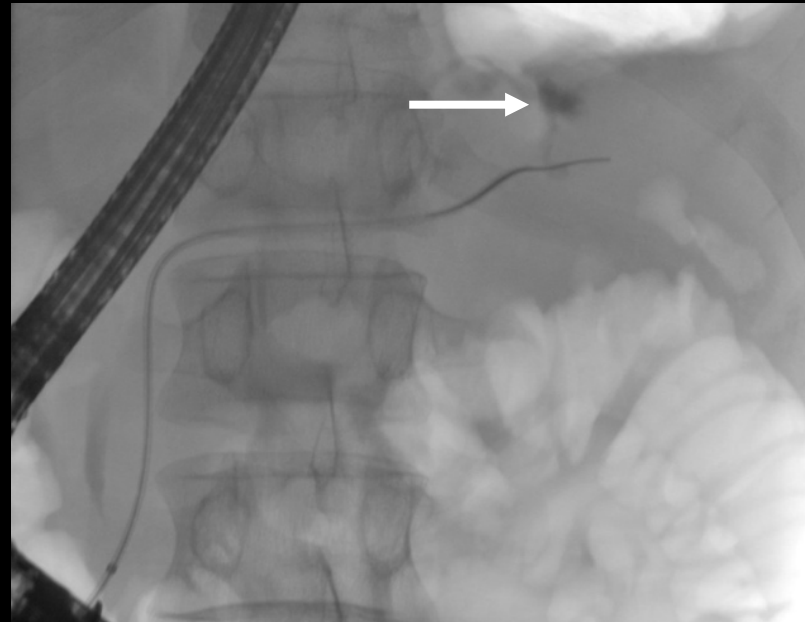
40-year male kicked by a horse. Axial contrast enhanced CT shows a full thickness laceration through the tail of the pancreas (yellow arrow). The laceration involves the main pancreatic duct with contrast extravasation (white arrow) on ERCP (Grade 3 injury). The patient was treated non-operatively with a pancreatic stent insertion.

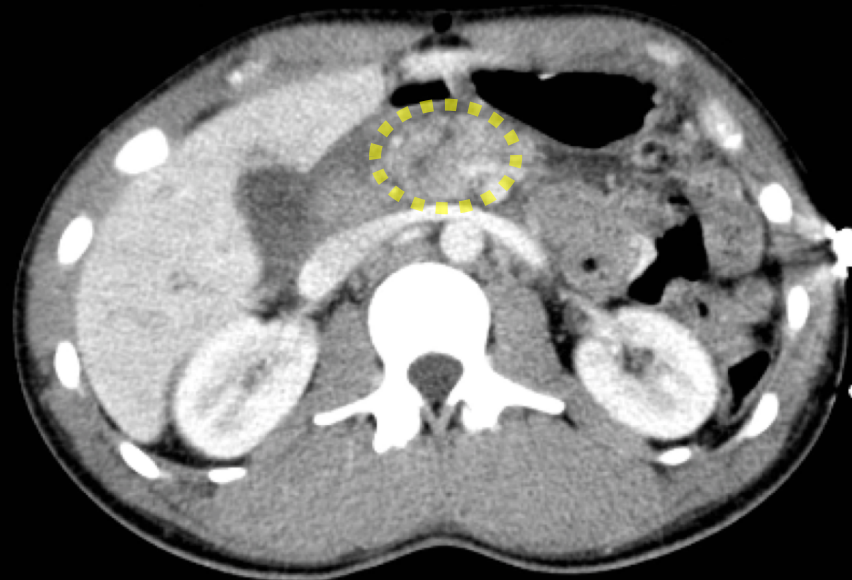
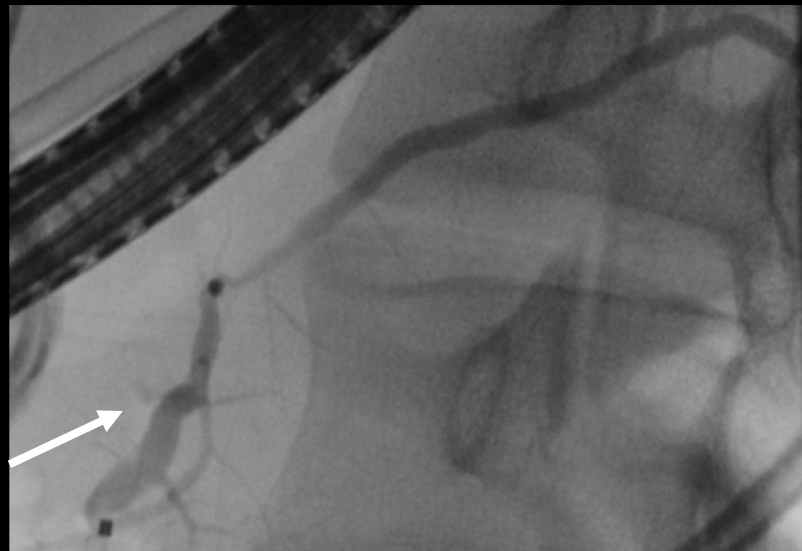
22-year-old male involved in a high-speed MVA. Axial contrast enhanced CT shows a complex laceration through the pancreatic neck (yellow circle). ERCP shows a contour deformity of the main pancreatic duct at the head and neck with subtle contrast extravasation (white arrow) (Grade 4 injury). The patient was treated non-operatively with insertion of a pancreatic stent.

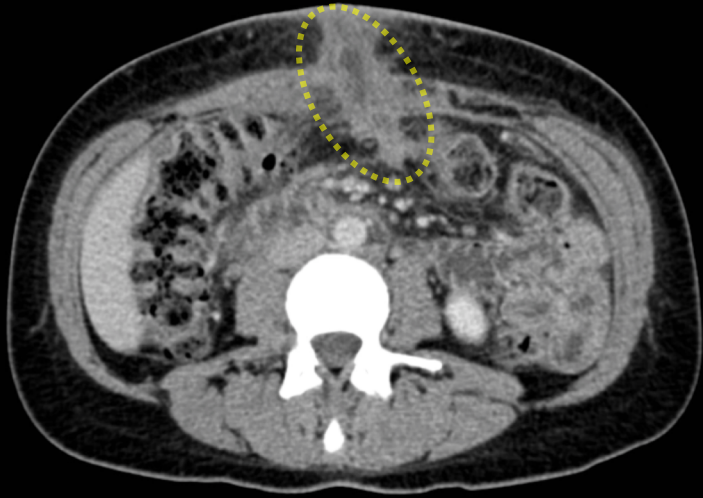
MRI Findings: ^{10, 11}

- Laceration – linear T2 increased intensity
- Contusion – ill-defined T2 increased intensity
- Hematoma –heterogenous T1 high signal
- Discontinuity of the pancreatic duct.

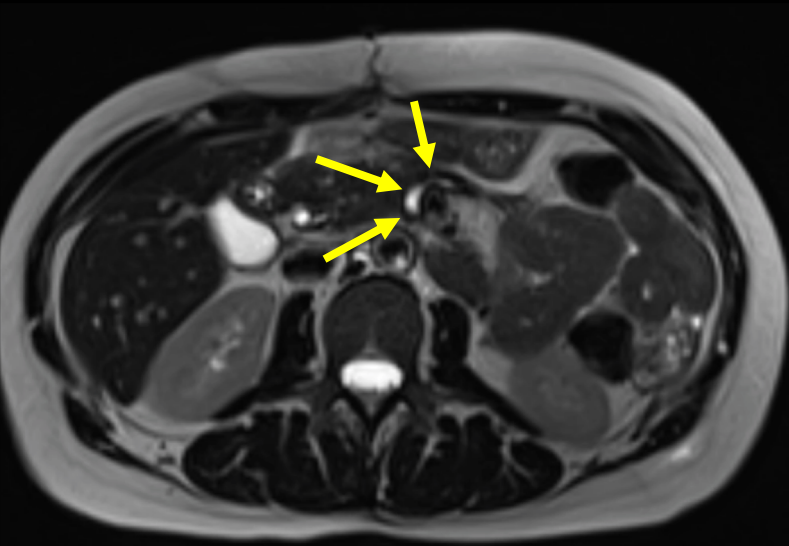
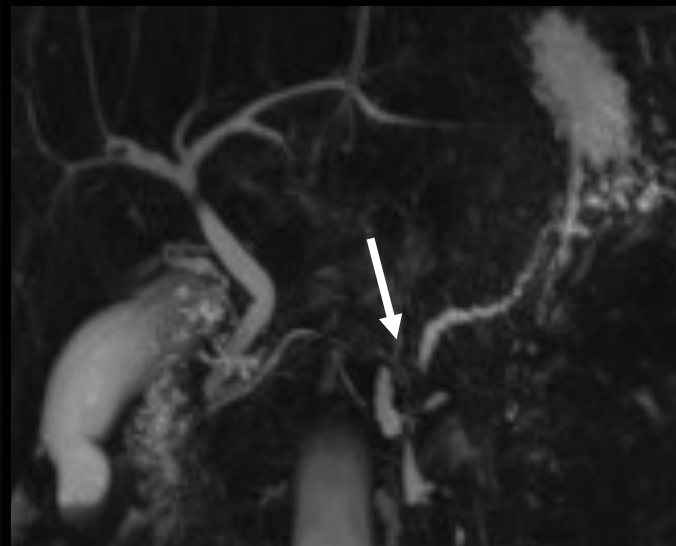
55 year old man with abdominal trauma 2 months prior. Axial contrast enhanced CT (top left) shows a large fistula tract (yellow circle) extending to the anterior abdominal wall. Axial T2 images (top right, bottom left) delineates the fistula tract (yellow arrows). Focal discontinuity (white arrow) of the main pancreatic duct is evident on the secretin MRCP images (bottom right), consistent a pancreatocutaneous fistula. The patient successfully underwent a Roux-en-Y procedure.

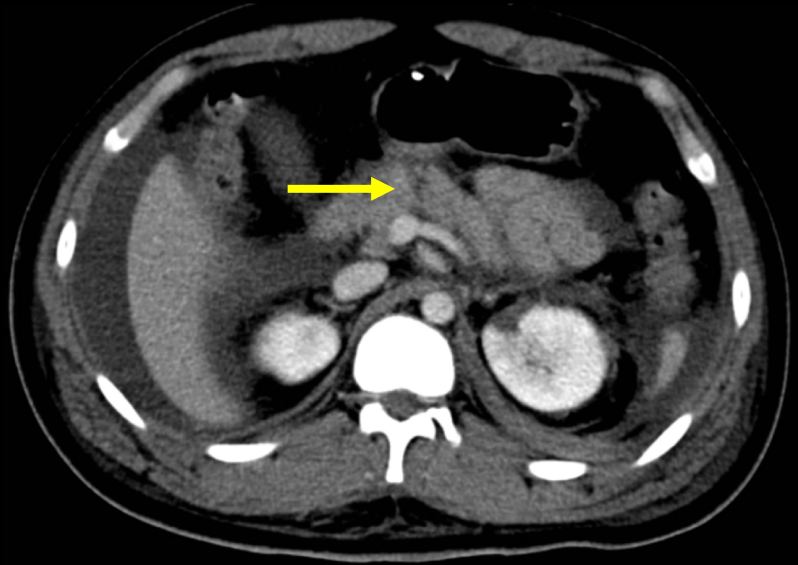
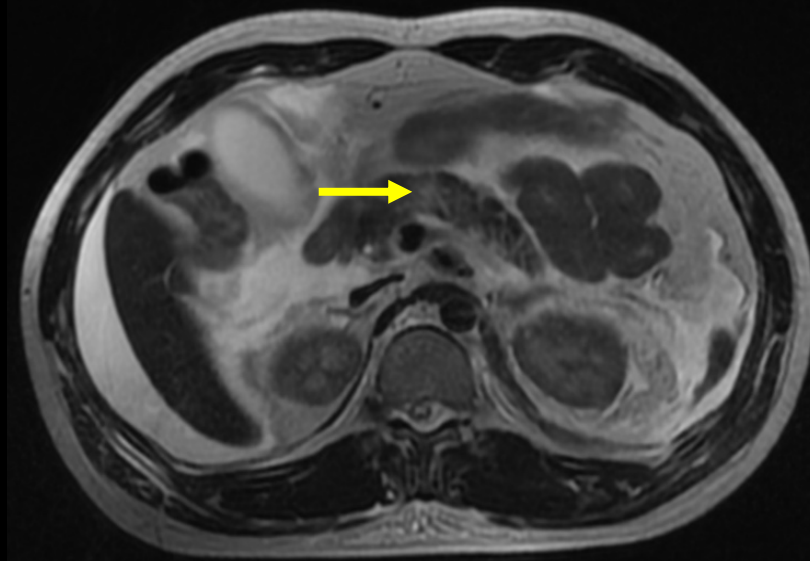
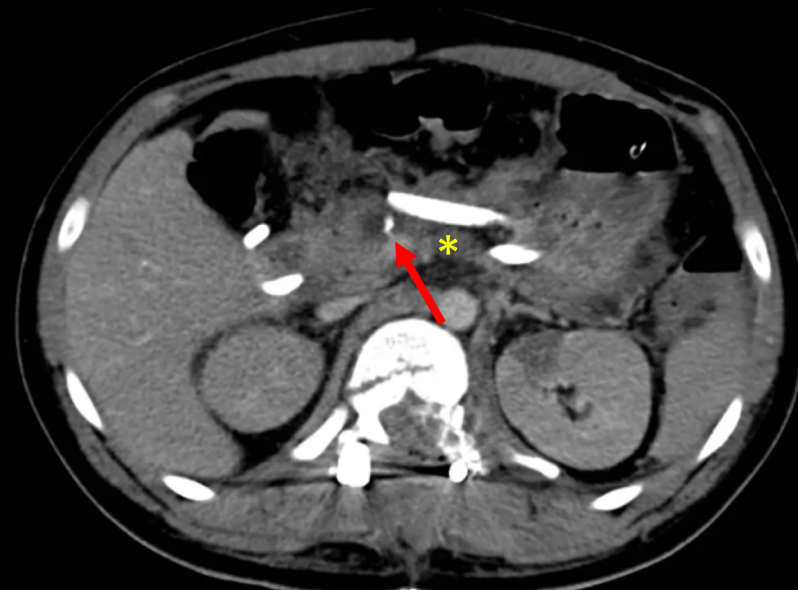
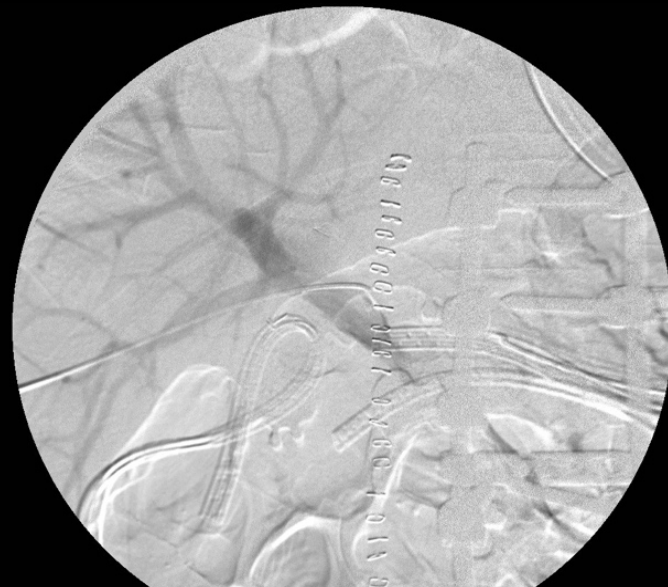
20 year old pedestrian struck by a car. Axial contrast enhanced CT (top left) and axial T2 MRI (top right) images show a full thickness laceration through the neck of the pancreas (yellow arrow). The patient underwent a distal pancreatectomy with surgical clips at the site of surgical resection (red arrow) and a small volume of fluid within the pancreatic resection bed (star). At the time of surgery the patient underwent an autologous islet cell transplant into the liver (bottom right) administered via a catheter within the portal vein.
