An Imaging Primer of Pancreatic Trauma: A Rare but Important Injury Spectrum

Tarek N. Hanna MD; Carrie Hoff MD; Sidd Kosaraju MD; Joseph Graves MD;
Keith D. Herr MD; Jihoon Lim MD; Gayatri Joshi MD

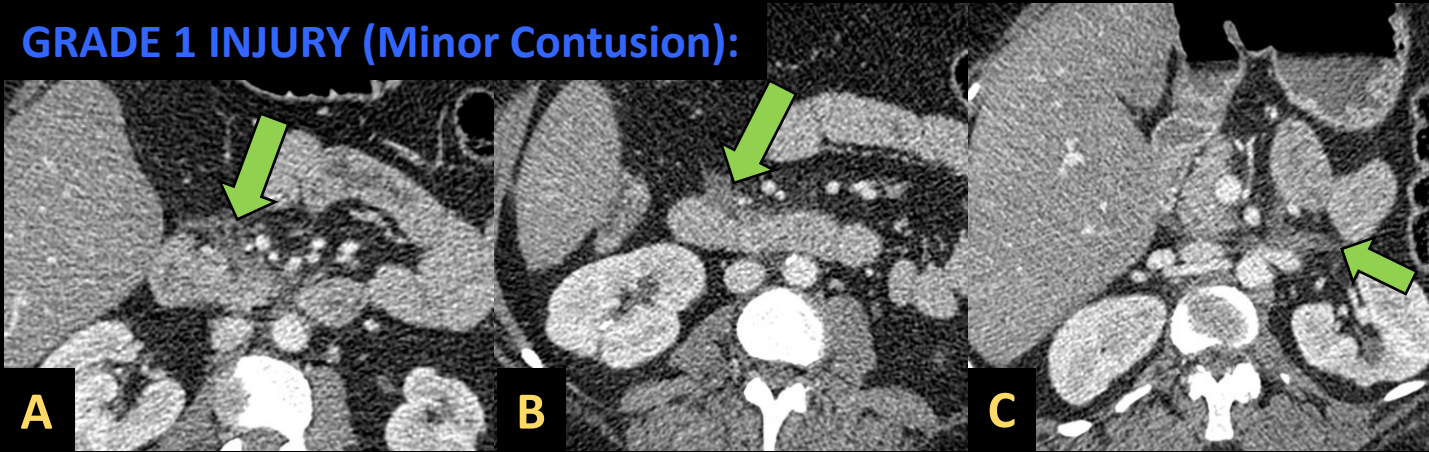
GRADE 1 INJURY (Minor Contusion):

A-C. Status-post MVC. Axial CECT images show mild stranding adjacent to pancreatic uncinus process and in the left anterior pararenal space (**arrows**) suggesting *minor pancreatic contusion* without visible focal parenchymal abnormality. Peri-pancreatic fluid is a combination of hemorrhage and edema. Pt had elevated pancreatic enzymes.

Peripancreatic fluid without parenchymal injury is a presumed contusion or shallow nonvisible laceration, AAST Grade 1 Injury

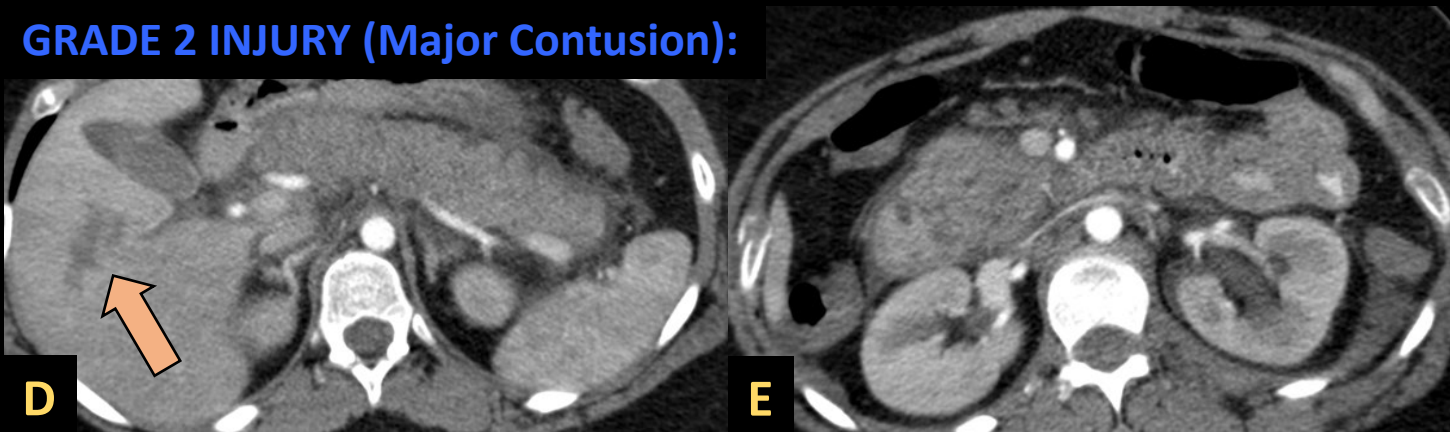
GRADE 2 INJURY (Major Contusion):

D,E. Status-post blunt trauma. Axial CECT images show fat stranding surrounding the diffusely swollen pancreas. The pancreatic parenchyma is slightly heterogeneous without visible laceration. This is a *major pancreatic contusion* without focal laceration or imaging findings of main duct injury. There is also a liver laceration (**arrow**).

Major pancreatic contusion is an AAST Grade 2 Injury: the distinction between what constitutes a minor vs. major contusion is not established. In the authors' expert opinion, a contusion which involves >25% of the pancreas is considered major.

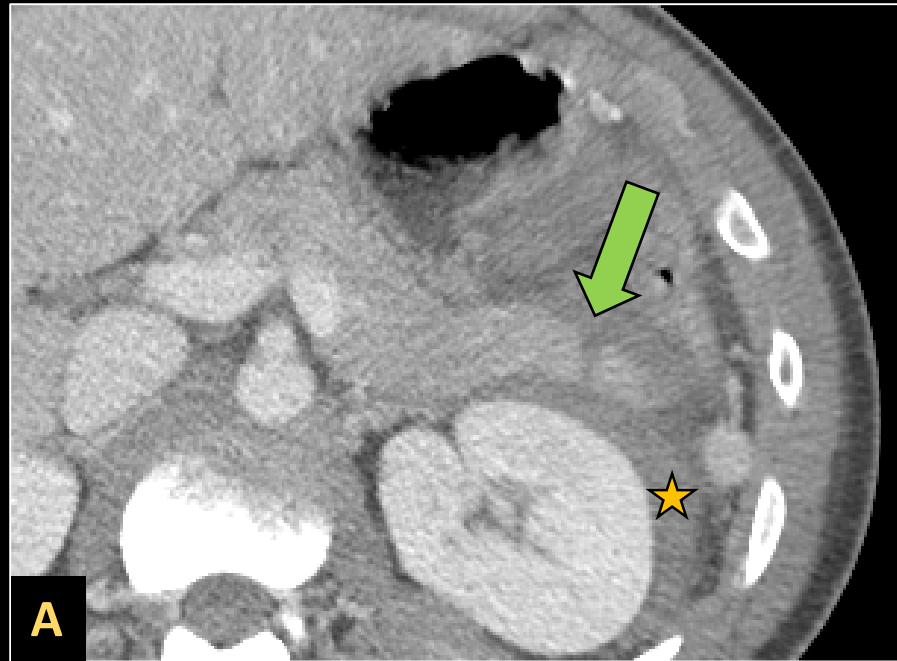
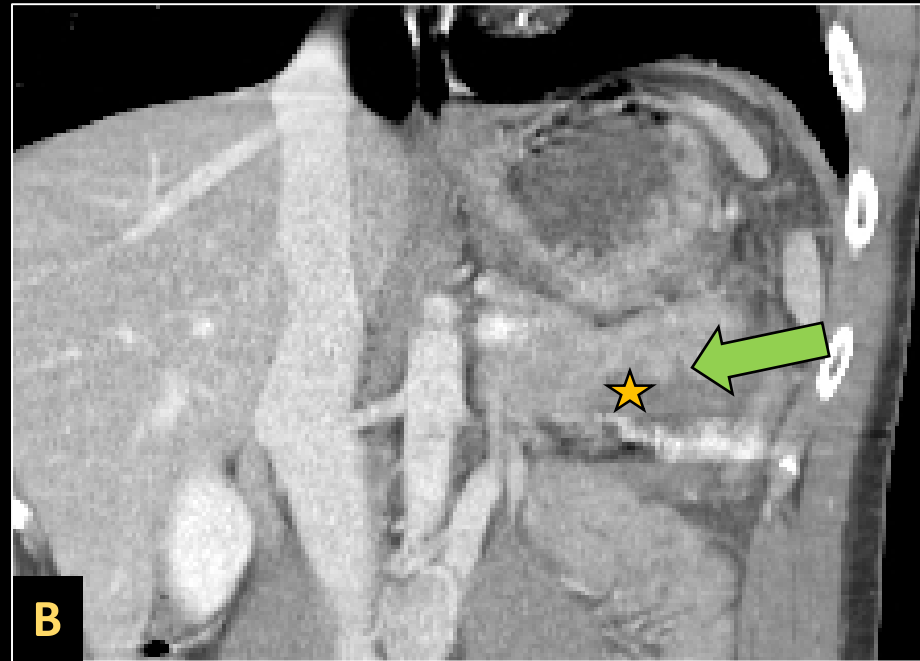
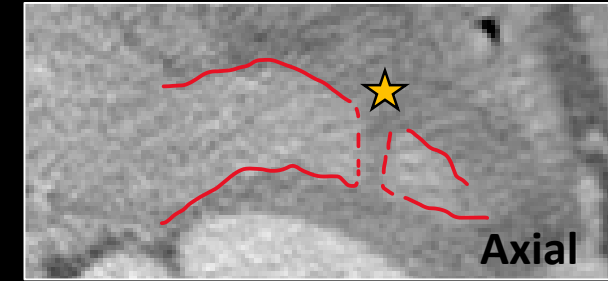
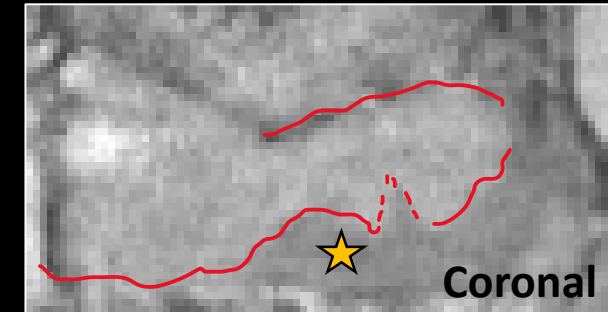
A. Axial CECT image suggests nearly full-thickness laceration to the pancreatic tail (**arrow**). **B.** Coronal CECT image clarifies that this laceration only traverses the inferior aspect of the pancreas (**arrow**), sparing the main pancreatic duct. Magnified images are presented to the right with the laceration outlined in **dashed red** and the pancreas in **solid red**. There is peripancreatic and perirenal retroperitoneal hemorrhage (**stars**).

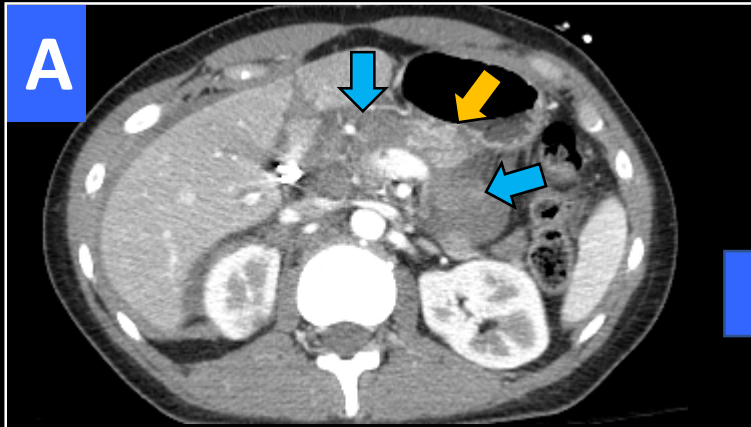
Axial CECT image shows normally enhancing pancreatic parenchyma in the mid-body (**arrow**), with upstream and downstream regions of pancreatic contusion (**arrow**).

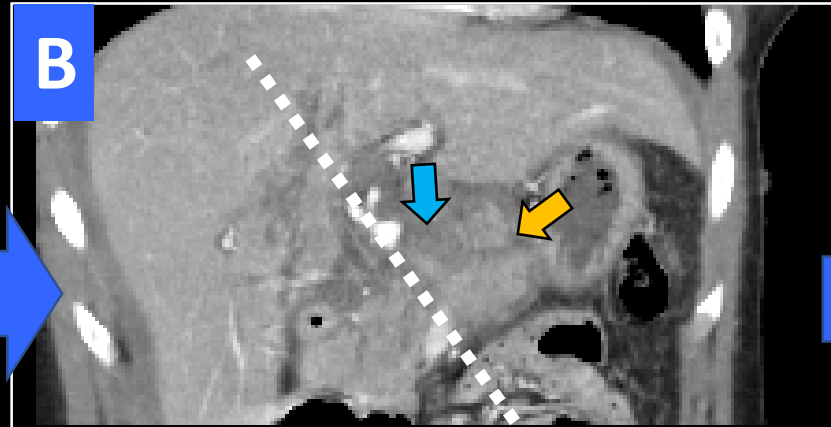
Portal-SMV axis (**dashed line**) divides “proximal” from “distal” pancreas by AAST terminology. Coronal CECT image shows parenchymal contusion (**arrow**) extending deep to the level of the main duct (**arrow**). Note the effacement of peripancreatic and porta-hepatic fat planes by blood products.

AAST Grading: There is major contusion (Grade 2) with injury extending inferiorly to the main pancreatic duct without injury on both sides of the duct, indicating no definite duct injury by CT. Since there are two distinct Grade 2 injuries, advance one AAST grade to **AAST Grade 3 pancreatic Injury**.

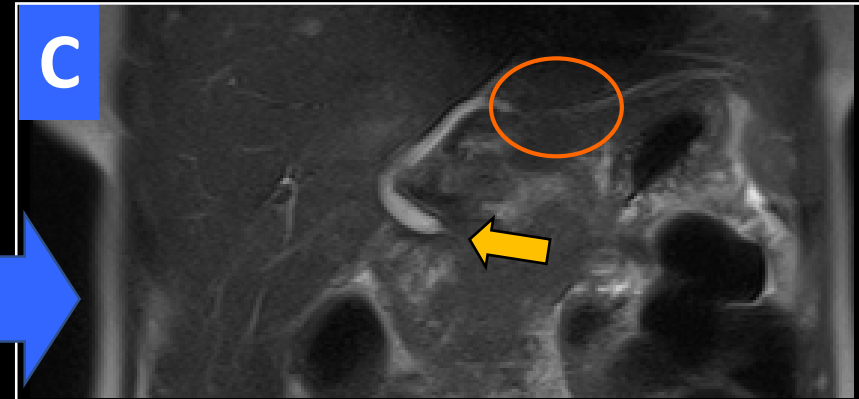
Follow-up MRI: Coronal T2w MR image shows distal CBD narrowing (**arrow**) and a 2.5 cm segment of main pancreatic duct narrowing with possible discontinuity (**circle**) at site of prior injury on initial CT. During surgery, this was found to be due to edema with mass effect on the duct rather than intrinsic ductal injury.

Take Home Point: The main pancreatic duct is best evaluated by MRI/MRCP. Analysis of peripancreatic fluid was helpful in proving false-positive duct injury on MR.

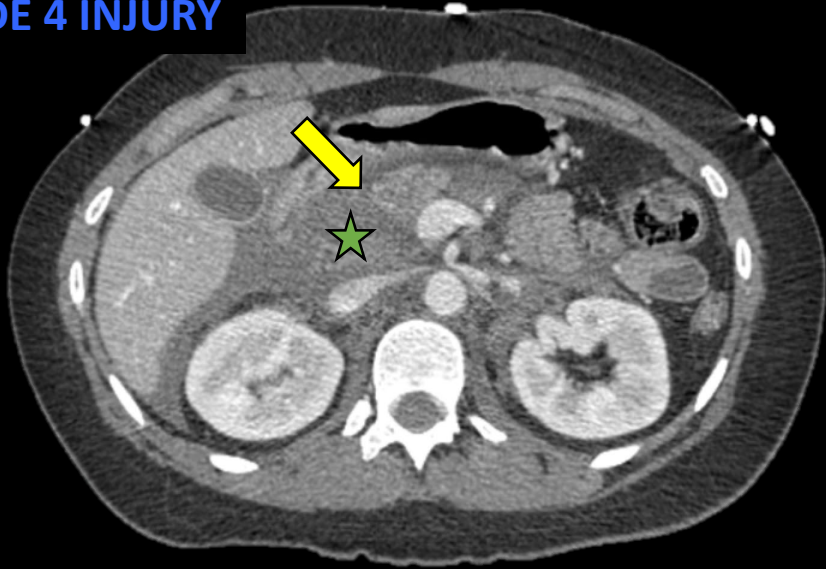
GRADE 4 INJURY

This MVC patient has edema and hypo-enhancement of the pancreatic head (**star**) with peripancreatic hemorrhage in region of ampulla. There is a sharp margination between normal and abnormal pancreas, suggesting a proximal pancreatic laceration (**arrow**). This is consistent with AAST Grade 4 injury.

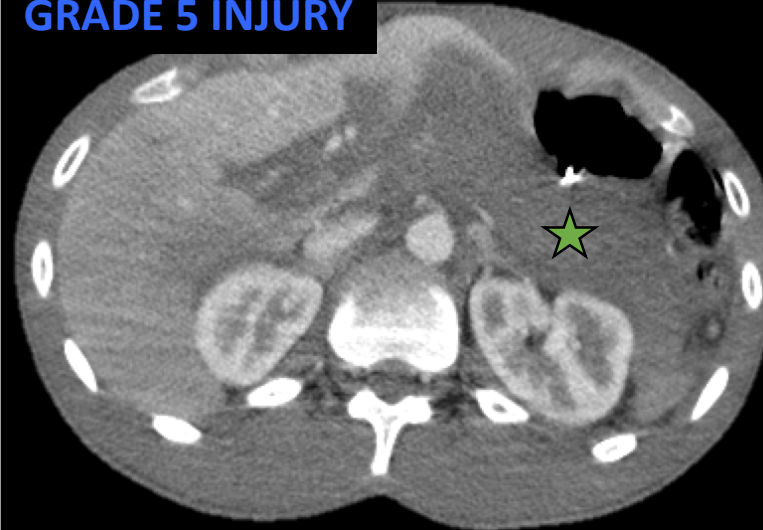
GRADE 5 INJURY

Diffuse parenchymal Injury: Note the diffusely swollen, hypodense pancreatic parenchyma (**star**). There is massive disruption of pancreas, including the head.

Peripancreatic hemorrhage: The hypoattenuating pancreas is difficult to distinguish from the peripancreatic blood.

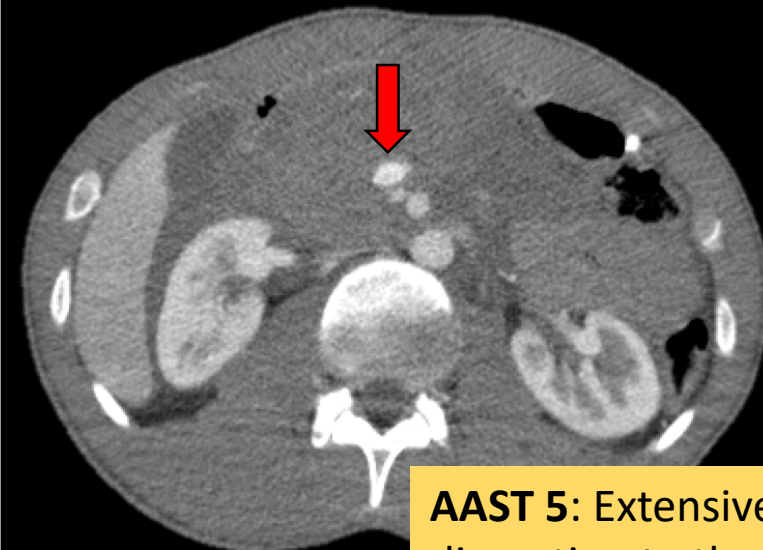
Vascular injury: Pooled focus of contrast extravasation (**arrow**) noted anterior to the take-off of replaced hepatic artery (which arises from the SMA). Note attenuation is greater than that of the aorta on this portal venous phase.
