CT FEATURES OF MALPOSITIONED GENITOURINARY CATHETERS IN THE ED

AHMED SOBIEH, MD, PHD, HEMANG KOTECHA, DO, HAO LO, MD
DEPARTMENT OF RADIOLOGY
UMASS MEMORIAL MEDICAL CENTER
UNIVERSITY OF MASSACHUSETTS MEDICAL SCHOOL

OBJECTIVE: PRESENT SERIES OF MALPOSITIONED GU CATHETERS AND COMPLICATIONS.

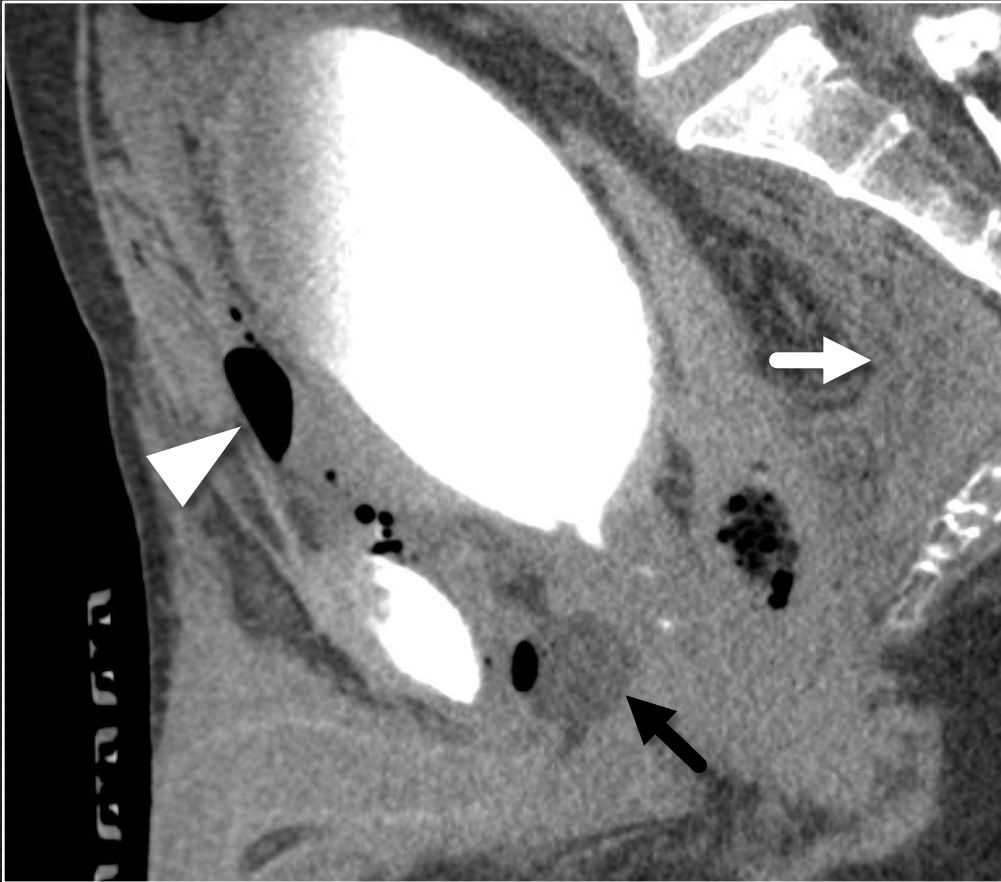
Fig 1. Delayed phase scan from contrast-enhanced CT in 26-year-old male involved in MVC with Foley catheter placed in ED. Sagittal image depicts Foley catheter traversing bulbar urethra, with tip and balloon (black arrow) anterior to prostate, extraperitoneal gas (white arrowhead), and presacral hematoma (white arrow). Pelvic fractures are not pictured.

MOST COMMON LOCATIONS OF MALPOSITIONED FOLEY CATHETERS: PROSTATIC URETHRA, URETER
ASSOCIATED COMPLICATIONS: URETERAL RUPTURE, HYDROURETERONEPHROSIS, URINARY OUTFLOW OBSTRUCTION (1).

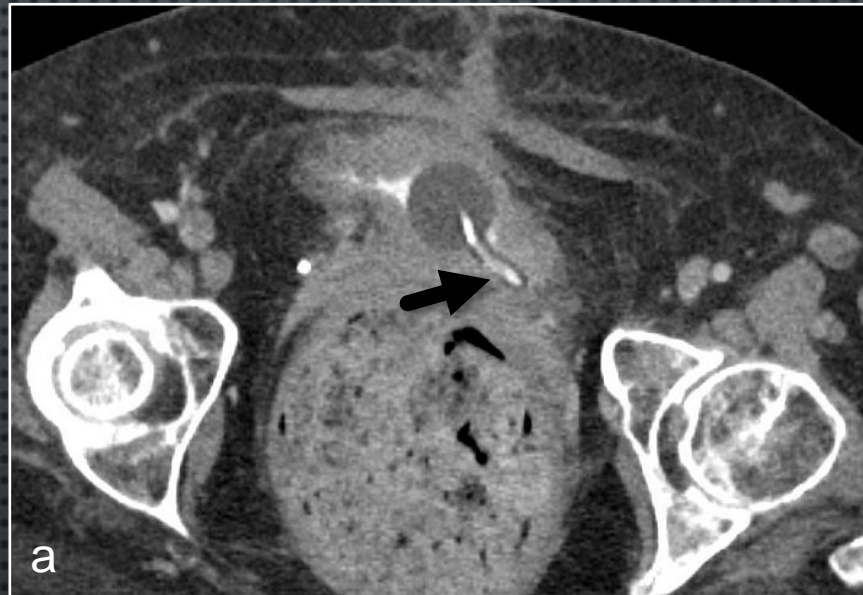
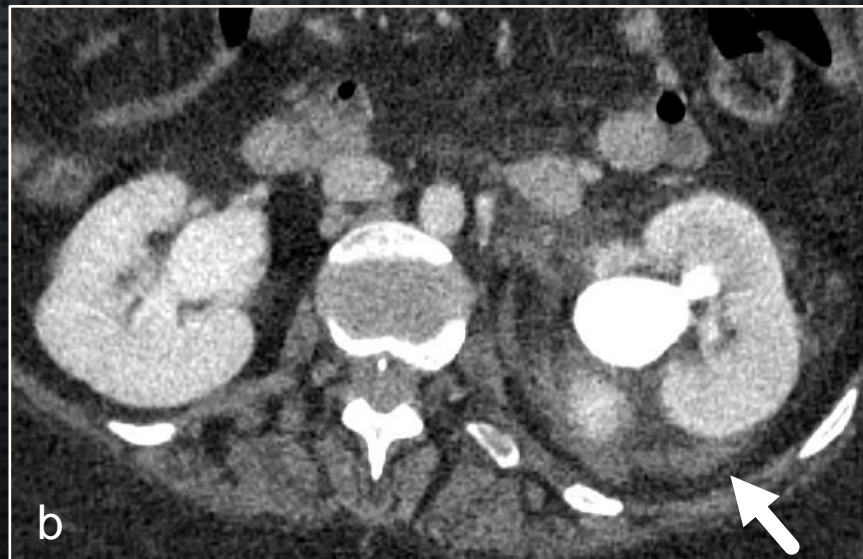
Fig 2. Contrast-enhanced CT in 41-year-old female with multiple sclerosis and neurogenic bladder presenting with left flank pain 7 days post suprapubic bladder catheterization. Axial image (a) shows suprapubic catheter tip extending into left ureteral orifice (black arrow). Axial image (b) shows left hydronephrosis, delayed nephrogram, and perinephric fat stranding (white arrow).

**MOST COMMON LOCATIONS
OF MALPOSITIONED
SUPRAPUBIC CATHETERS:
RECTUM, SMALL BOWEL**

HEMORRHAGE, PAIN,
URINARY TRACT INFECTION,
URINARY LEAK (2).

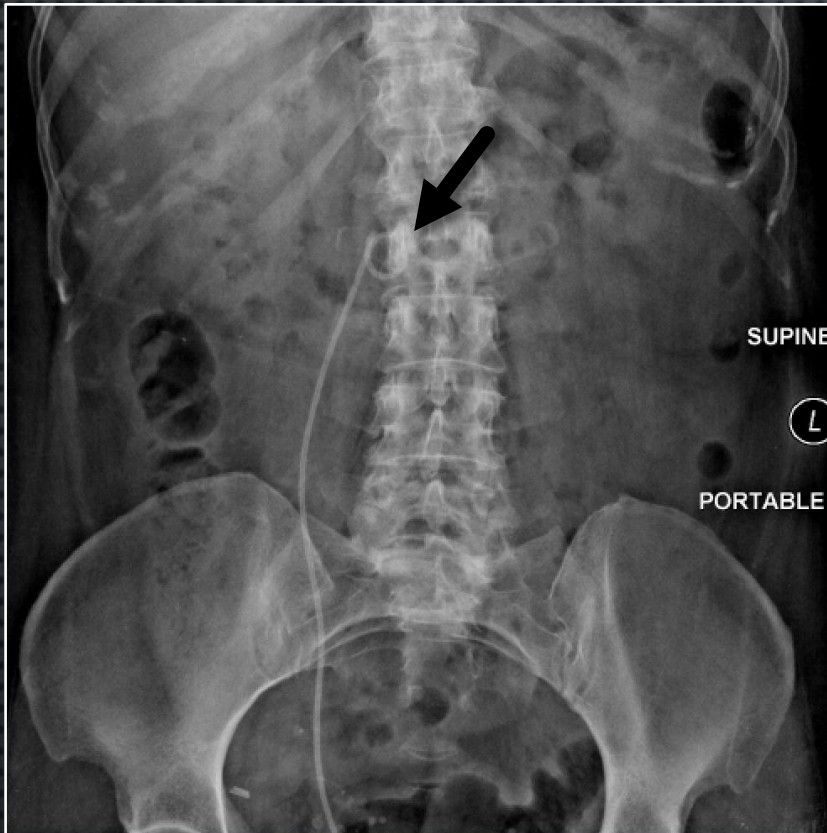
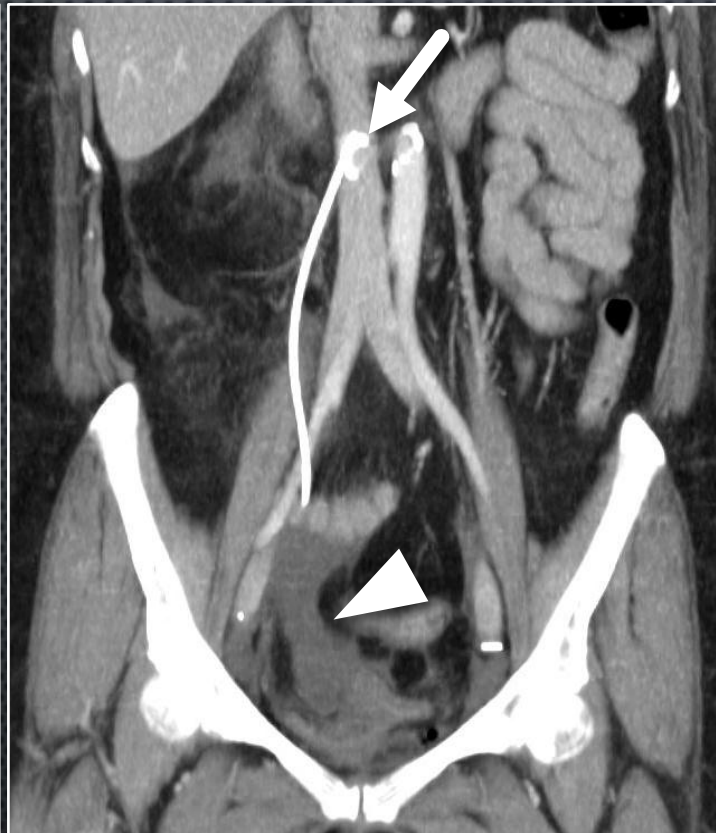
Fig 3. 71-year-old post laparoscopic TAH-BSO and pelvic lymph node dissection for endometrial adenocarcinoma, complicated by right ureteral transection and repair. KUB (a) shows right ureteral stent located abnormally medially (black arrow). Coronal contrast-enhanced CT image (b) shows proximal pigtail of right ureteral stent within the IVC (white arrow) and pelvic urinoma (arrowhead). Surgery confirmed inadvertent anastomosis of right ureter to right gonadal vein.

MOST COMMON LOCATIONS OF MALPOSITIONED URETERAL STENTS: URETER, COLLECTING SYSTEM, RENAL PARENCHYMA

ASSOCIATED COMPLICATIONS: URINOMA, HEMATOMA (3).
